# Before and After Case Study

## CAMDEN YMCA 50 METRE MEMORIAL POOL

Master pool painter, John Townsend of [www.poolpainters.com.au](http://www.poolpainters.com.au), recently resurfaced the Camden YMCA 50 metre Memorial Pool in the South-Western suburbs of Sydney. This was a large commercial pool resurfacing project using LUXAPOOL® Epoxy in Pacific Blue colour, with the lane lines painted in LUXAPOOL® Epoxy Black.

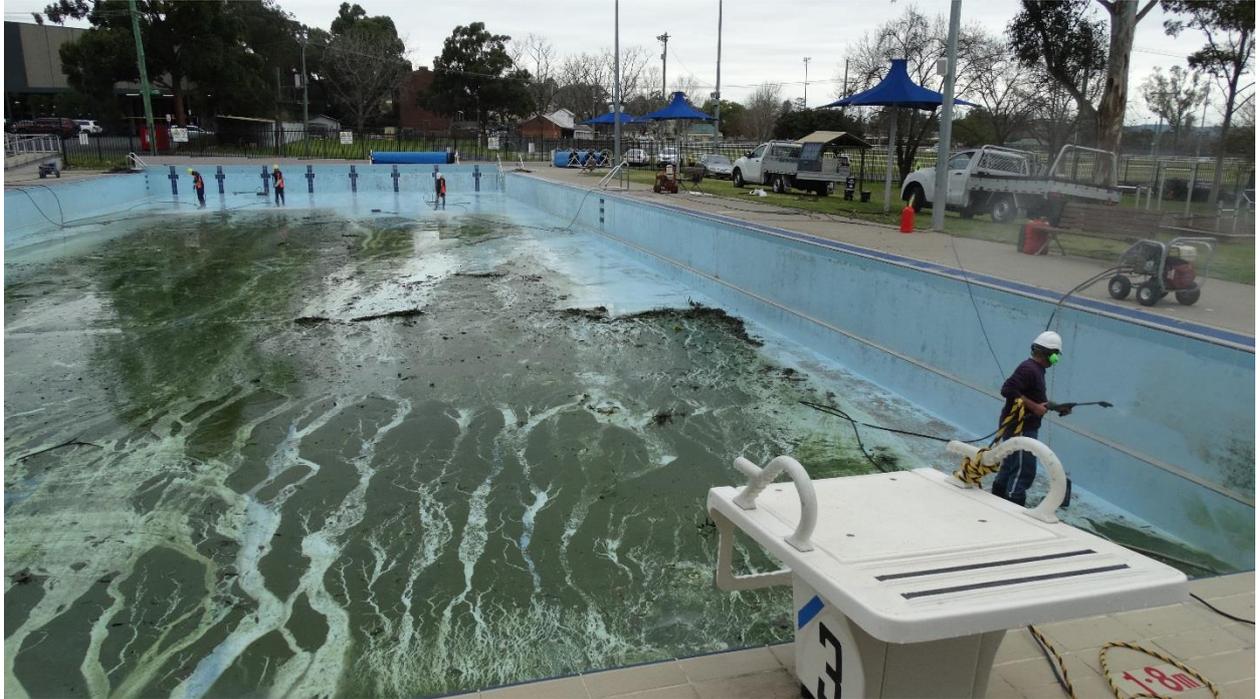
Image 1

**BEFORE:** Camden pool is emptied to reveal sludge and algae which has built up over the Winter period.
